# REPORT ON CONSERVATION OF MONUMENTS 2002-2005

DEPARTMENT OF ARCHAEOLOGY GOVERNMENT OF TAMIL NADU, CHENNAI - 600 008

### CONSERVATION WORKS TO TIRUMALAI NAYAKKAR MAHAL, MADURAI

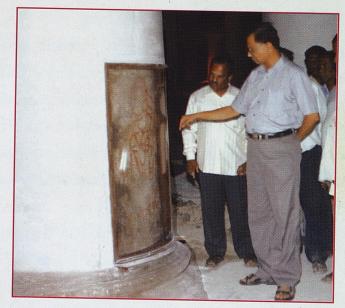
Nayak Paintings found in Pillars at T.N. Mahal, Madurai

- 1. The Nayak paintings found in pillars and those which are intact needs to be chemically cleaned and preserved carefully with plastic sheets visible for public.
- 2. The Darbar hall plastering should be chemically cleaned, fat lime polished coat should not be applied and cleaning should be made in accordance with the model pillar.

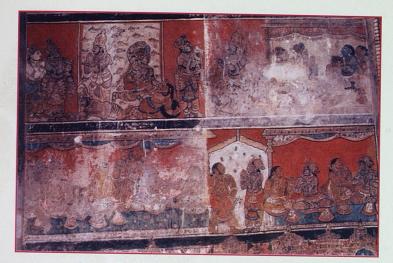
Mural Paintings - Before Conservation

The ground and carrier of the mural base are found to be eroded / flaking out in some places. Most of the walls and stucco works are blistered due to saline and capillary action. Dampness is also found on the flooring portion of mahamandapam during rainy days. The pillars are of cut stone segments set in lime mortar with facing of burnt bricks in lime mortar. They are resting on the stone pedestals and have cut stone capital at its top. It is observed that the pillar have been finished with seashell lime Chettinad plaster. Traditional plastered pillars at mahamandapam are found to be covered due to the subsequent white washed layers; pot holes are also found elsewhere.

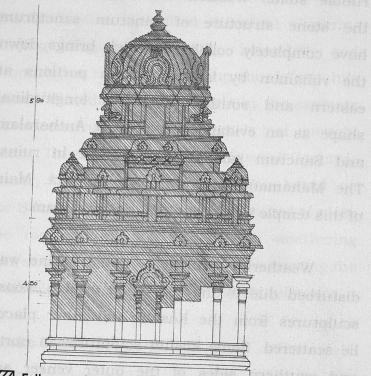
Fallen portion of Sivan Koil Vimanam at Ulagapuram

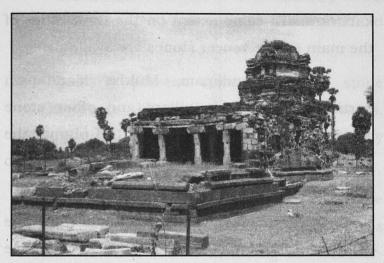
Pachil Amaleeswarar Temple - Alagiya Manavalam - Before Conservation

This temple was almost in a dilapidated condition and was on the verge of collapse. Whole structure including the vimanam having the brick work was leaning towards western side. The vimanam was supported by new
