# REPORT ON CONSERVATION OF MONUMENTS 2002-2005

DEPARTMENT OF ARCHAEOLOGY GOVERNMENT OF TAMIL NADU, CHENNAI - 600 008

### CONSERVATION WORKS TO TIRUMALAI NAYAKKAR MAHAL, MADURAI

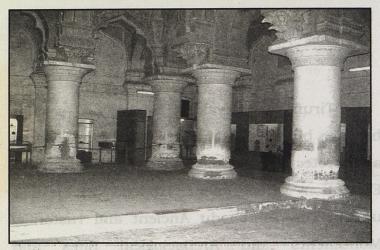
T.N. Mahal, Madurai

Tradition says that Tirumalai Nayakkar took the help of Italian Architects in designing the building. Due to the weathering action certain defects have been noticed. Immediately, the Government have formed an expert committee to study the causes for deterioration of the structures. A team of professors of Madurai Thiyagaraja Engineering College conducted various structural stability tests like plate load test, compressive strength of bricks, testing the lime mortar & teak wood etc. and submitted their detailed report.

- Cracks in roof and walls were injected through hand / machine grouting after mixing the extract of gallnut and jaggery with combination mortar.
- Pillars at courtyard were de-plastered with five layers. while execution it was reobserved that the central core of the pillar was constructed with granite stone of semi circular in circular shape.
- Apart from this 32 mural paintings of Tirumalai Nayakkar period were also de-plastering. These while identified shows that the ladies with paintings Kalasam, Mulaippari and other auspicious inmates with things, welcoming the Kulavai sound which are the traditional welcome of the Pandya dynasty. As per the advise of Special Commissioner Thiru T.S.Sridhar, IAS, the paintings have been preserved by enclosing them in PVC sheet so that the paintings are visible, while the rest of the column have been plastered to its original condition.

- After de-plastering the walls at inner and outer walls, mortar joints were racked out for increasing its binding strength.
- Cracked portions were strengthened by mending with pre-cast R.C.C lintels and grouted using the fine ground lime mortar 1:2 mixed with an extract of gallnut and jaggery.
- Dampness by percolation through a pillar was analyzed in various aspects. A big hole at the outer wall of the Swarga vilasam was identified and it was arrested through machine grouting.
- The flaked base Chettinad plastering in corridor and Swarga vilasam were completely removed upto its stone base. After grouting the segmental stone joints, the surface was stitched with bricks mixing with combination mortar. The coarse stone, quartz stone ground mortar was applied over the base plaster of 1:2 ratio. Over this the second coat

- The entrance ashlar masonry stone beam crack was supported with props and the load diverted to the floor using wooden rafters and tubular scaffolding. A groove of size having 0'-9" x 0'-8" was chiseled to a depth of 1 inch by using marble cutting machine to a length of 1.00 m on either sides of the center of the cracks. R.S. Joist

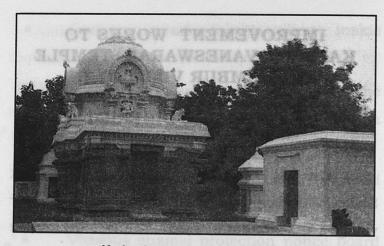
Kadambavaneswarar Temple

compound wall is found collapsed. A big bell tower with RCC pillar was constructed about 20'-0" height and the old giant bell is hanging. Inside sanctum sanctorum false ceiling was found missing but the evidence of its existence is available. Inner Karuvarai was plastered with cement mortar. Bricks are exposed due to blistering of plaster over the vimanam. Vegetation growth was found here and there. Cement flooring was made at the frontage of Mukhamandapam by over lapping the temple

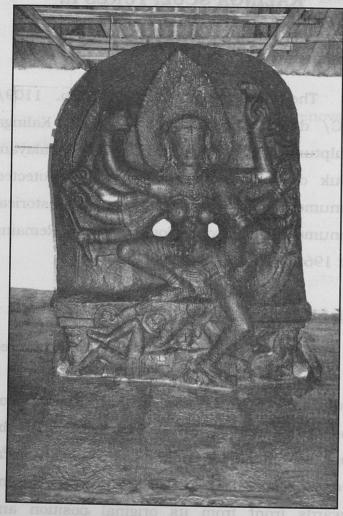
Kalinga Sculpture, Sengamedu

10<sup>th</sup> CE Kalinga sculptures were covered by A.C. sheet roof divided by two parts i.e. 5 sculptures in one room without applying oil and one sculpture of Kali in another room by applying oil and is under worship by the local people. This Gigantic Kali sculpture is leaning towards front from its original position and supported by counterweight with brick work on rear side; temporary electrical lighting arranged by the local people.

The Government have allocated funds of Rs. 2.00 lakhs under XI Finance Commission grants as recommended by the SLEC in G.O.Ms.No. 283 / TDC & RE (MA2) Department dated. 27.11.2003. Necessary works were identified by Thiru M.G.Chellapillai, a retired Archaeological Engineer of ASI who has been appointed as a Technical Consultant, after inspecting the site. Estimates were prepared by PWD authorities.
